NATIONAL AERONAUTICS AND SPACE ADMINISTRATION

APOLLO 14 MISSION REPORT

MANNED SPACECRAFT CENTER

MAY 1971

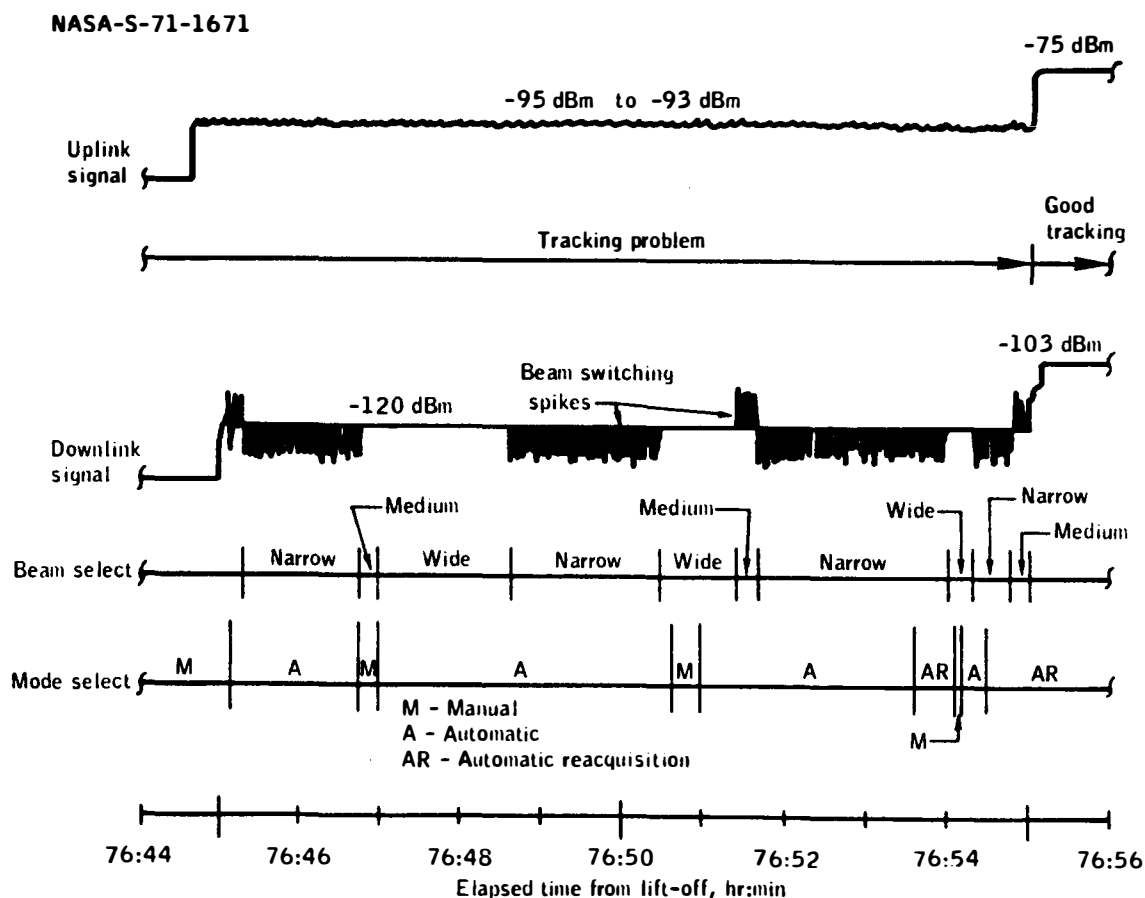
Figure 14-3.- Data from first period of anomalous operation.

The ground data signatures which show the first acquisition and tracking problems are illustrated in figure 14-3. The antenna started tracking a point approximately 5 to 8 degrees off the earth pointing angle at 76:45:00 elapsed time and continued tracking with low uplink and downlink signal levels for 10 minutes at which time a good narrow beam lock-up was achieved.

The low signals correlate with antenna pattern and gain data for a 5- to 8-degree boresight shift in the wide-beam mode. The direction of the spikes observed on the downlink data in figure 14-3 are consistent with switching between the wide and narrow beams. Conditions for a normal alignment and a misalignment of the wide and narrow beams are shown in figure 14-4. A 5- to 8-degree shift in the wide-beam mode boresight  
 NASA-S-71-1672

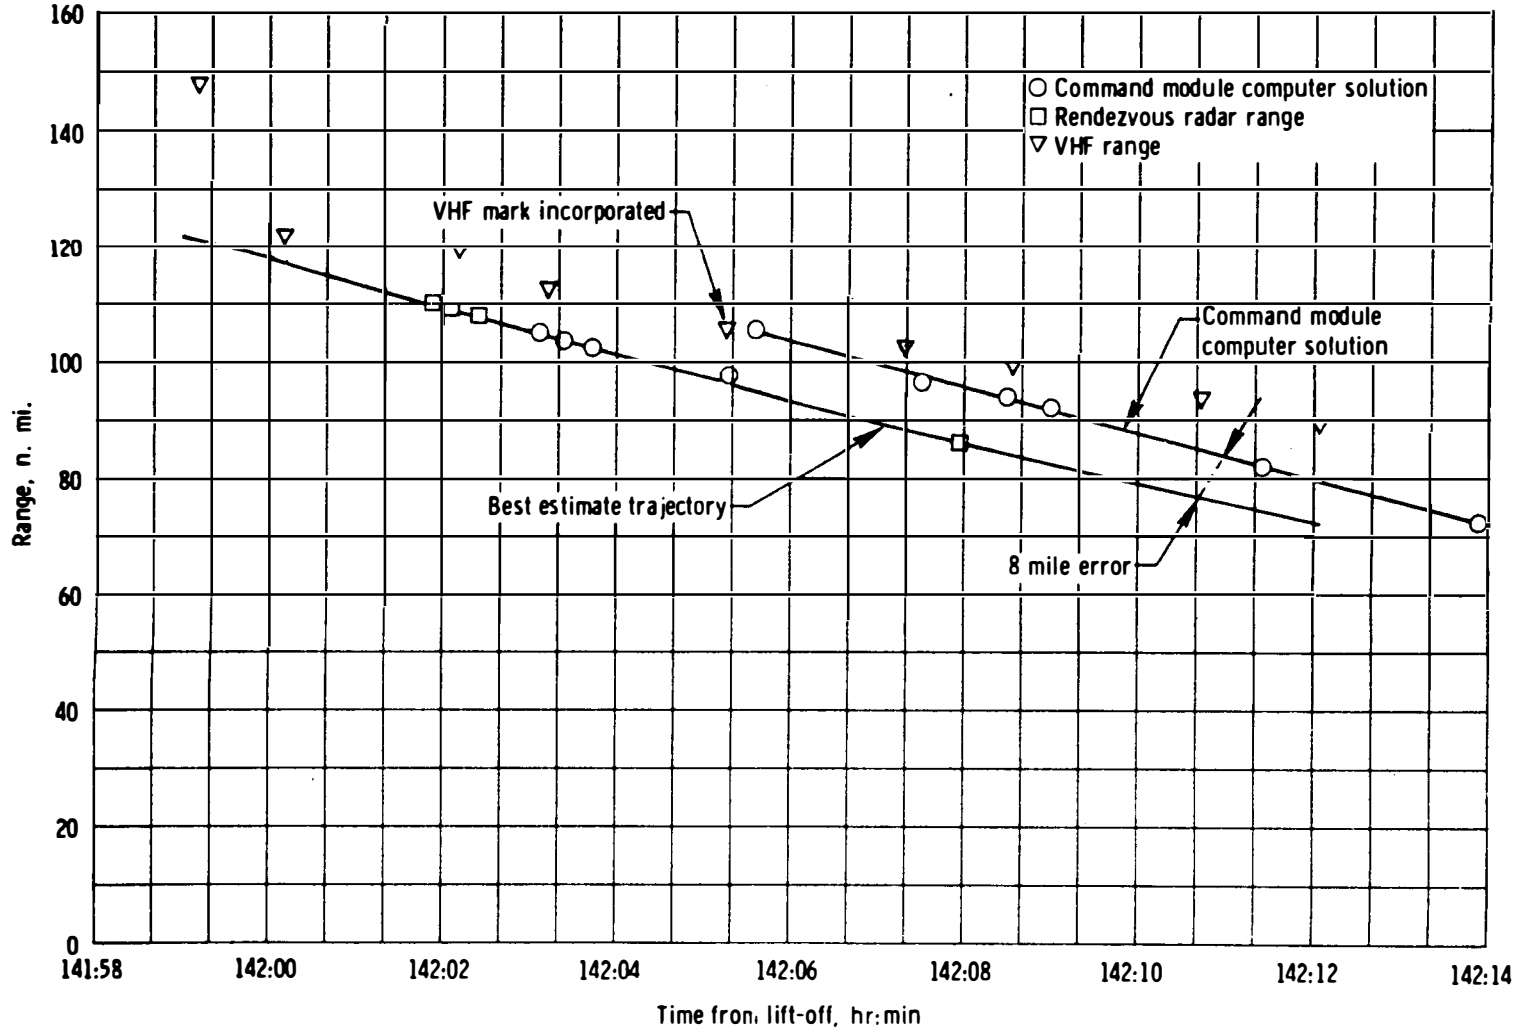
Figure 14-7.- Relative range comparisons during rendezvous.

Prior to lunar descent, the VHF ranging and rendezvous radar range measurements correlated closely. However, during the time period preceding terminal phase initiation, the VHF ranging system indicated erroneous measurements. During this same time period, numerous range tracking dropouts also occurred. The range measurements were in error by 5 to 15 miles when compared with the rendezvous radar range measurements (fig. 14-7). The VHF ranging data presented in the figure results from a number of different acquisitions. After terminal phase initiation, the

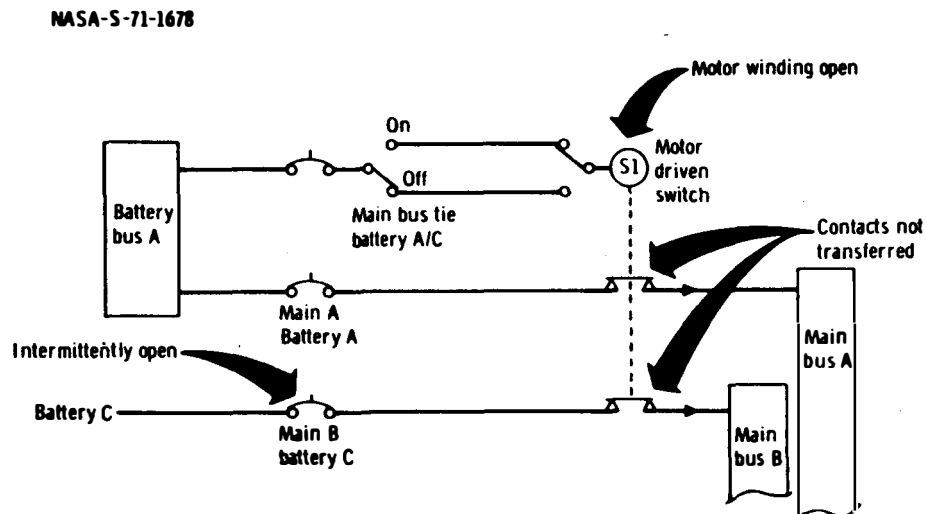
Figure 14-10.- Bus-tie circuitry.

During entry, when the main bus tie switches (motor-driven switches) were placed in the off position at 800 feet, main bus A should have de-energized; however, the bus remained on until after landing when the battery bus-tie circuit breakers were opened. Postflight testing showed that the main motor switch contacts were closed (fig. 14-10). Also, the

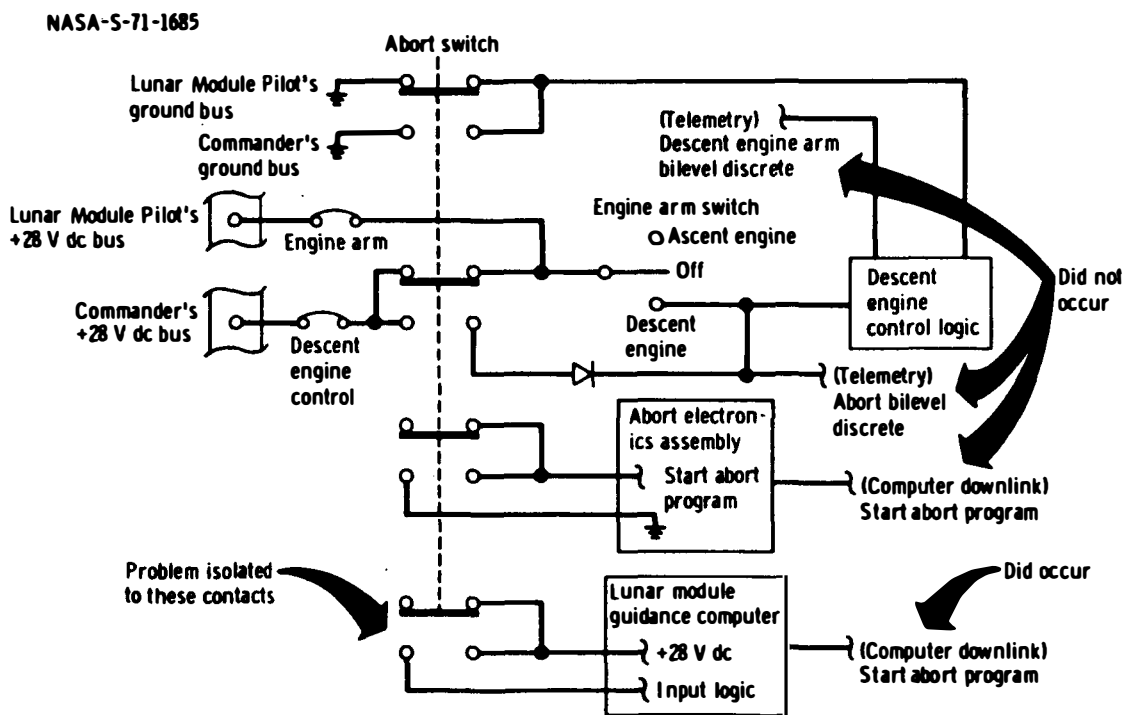
Figure 14-17.- Abort switch logic.

Prior to descent, the primary guidance computer received an abort command four different times. The computer would have reacted if the descent program had been initiated. The failure was isolated to one

- a. The abort stage switch descent-engine override function was removed from the abort-stage circuit breaker and placed on the logic power switch contact. This involved relocating one wire from one switch terminal to another.
- b. Each of the two engine stop switches were rewired so that two series contacts are required to close in order to stop the engine. Formerly, the two sets of contacts in each stop switch were connected in parallel so that closure of either would shut down the engine.

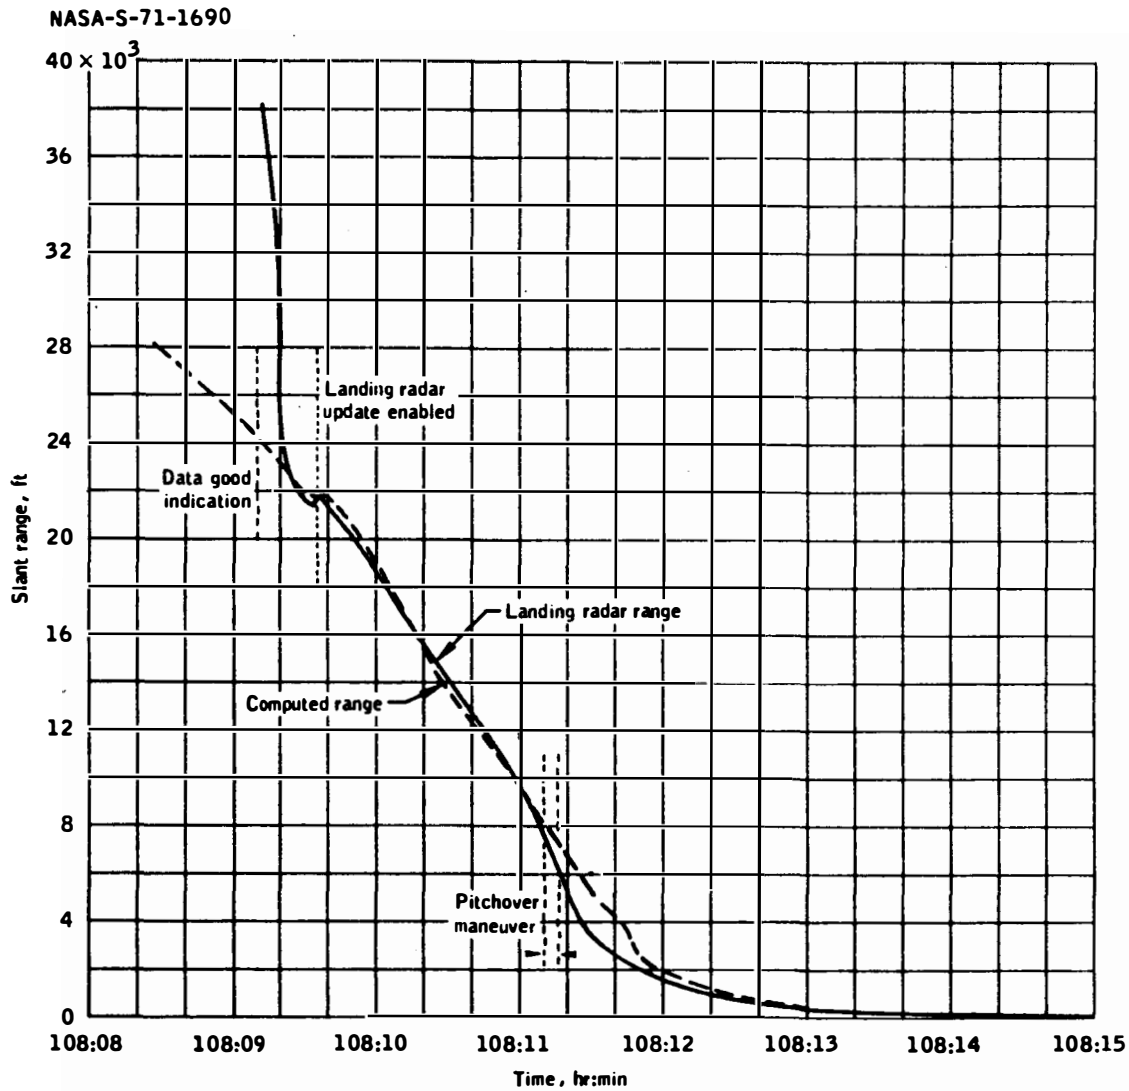
Figure 14-22.- Comparison of measured and computed slant range during powered descent.

The second condition which was not expected occurred after the circuit breaker was recycled. At this time the initial slant range reading was approximately 13 000 feet greater than that calculated from the operational trajectory. Several seconds later, the indicated slant range jumped from 32 000 to 25 000 feet. Subsequently, the landing radar readings compared favorably with the operational trajectory (fig. 14-22).

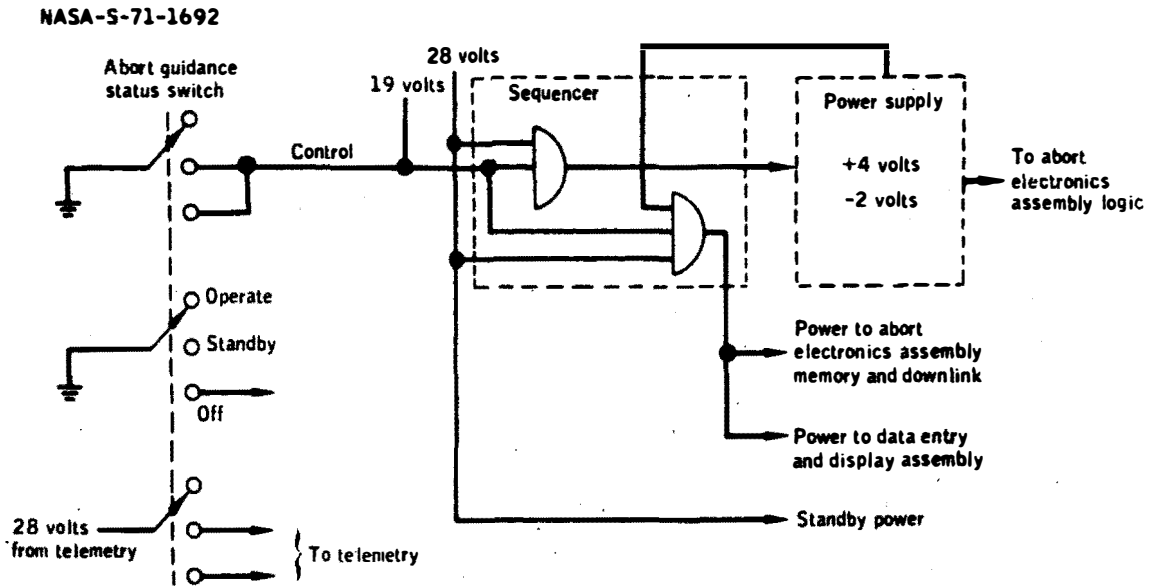
Figure 14-24.- Partial abort guidance system functional diagram.

The system was determined to have been in the standby mode after the failure by comparing expected and actual bus current changes that were observed at the time of the failure and the subsequent cycling of the circuit breakers. Further evidence of the system having been in standby was the absence of the warning light and master alarm at the time of the failure. If standby power in the electronics assembly were not maintained, clock pulses to the abort sensor assembly would have been lost and the warning light would have illuminated and the master alarm sounded. A warning light and a master alarm would also have occurred if the failure had been in the abort guidance status switch or the associated external wiring. These conditions isolate the failure to the power supply section or the sequencer of the abort electronics assembly (fig. 14-24).

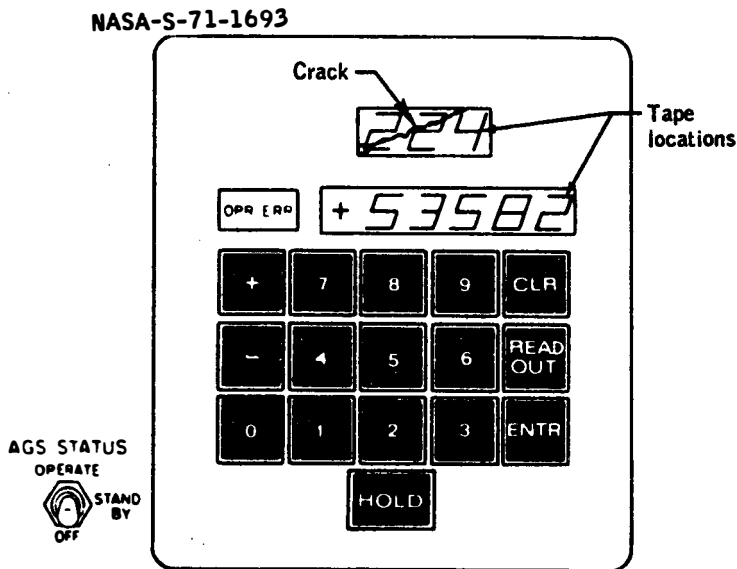
Figure 14-25.- Locations of crack and tape on data entry and display assembly.

The crew reported a crack in the glass across the address register of the data entry and display assembly. Figure 14-25 shows the assembly and the location of the crack. Figure 14-26 is an enlarged drawing of the glass and associated electroluminescent segments.

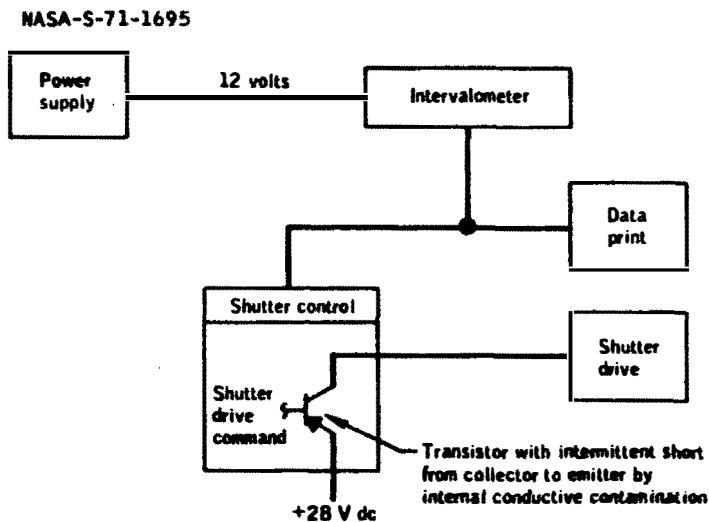
Figure 14-27.- Lunar topographic camera shutter control.

Postflight tests with the flight camera showed satisfactory operation in all simulated environments (pressure, thermal, and vibration) at one-g. An intermittent failure was found in a transistor in the shutter control circuit (fig. 14-27). The transistor was contaminated with a

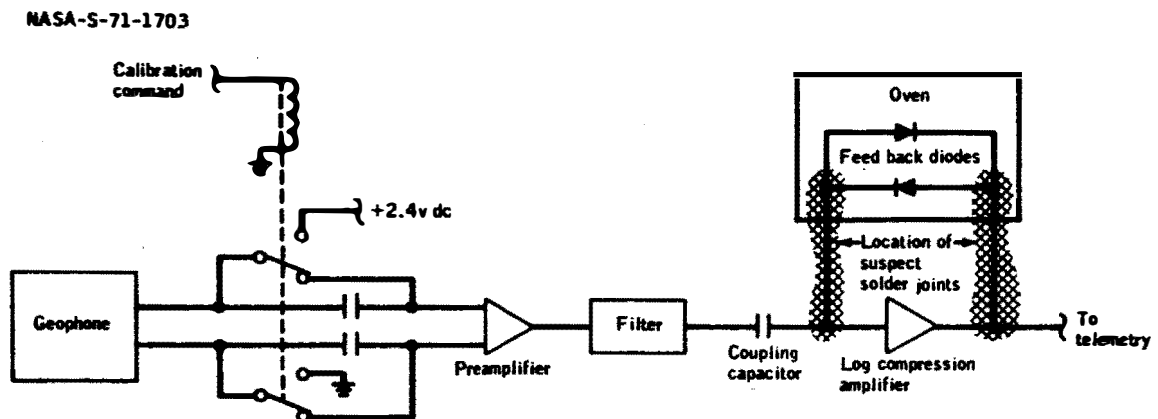
Figure 14-35.- Typical geophone channel.

As shown in figure 14-35, each geophone channel consists of a geophone, an input preamplifier, a low-pass filter, and a logarithmic compressor amplifier. The output of the logarithmic compressor feeds the instrumentation system. The logarithmic compressor is basically an inverting amplifier with exponential negative feedback. Two diode-connected transistors between the output and input of the amplifier supply the feedback. The first diode is used for positive-going and the second for negative-going input signals. The diodes for all three geophone channels (two per channel) are physically located in an oven which controls their temperature at 105° C.

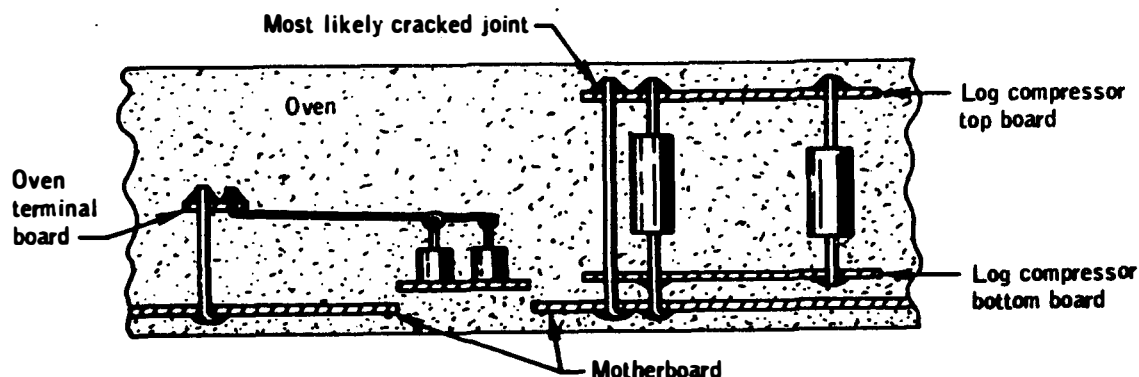
Figure 14-36.- Suspected cracked solder joints in amplifier.
