NATIONAL AERONAUTICS AND SPACE ADMINISTRATION

APOLLO 14 MISSION REPORT

MANNED SPACECRAFT CENTER

MAY 1971

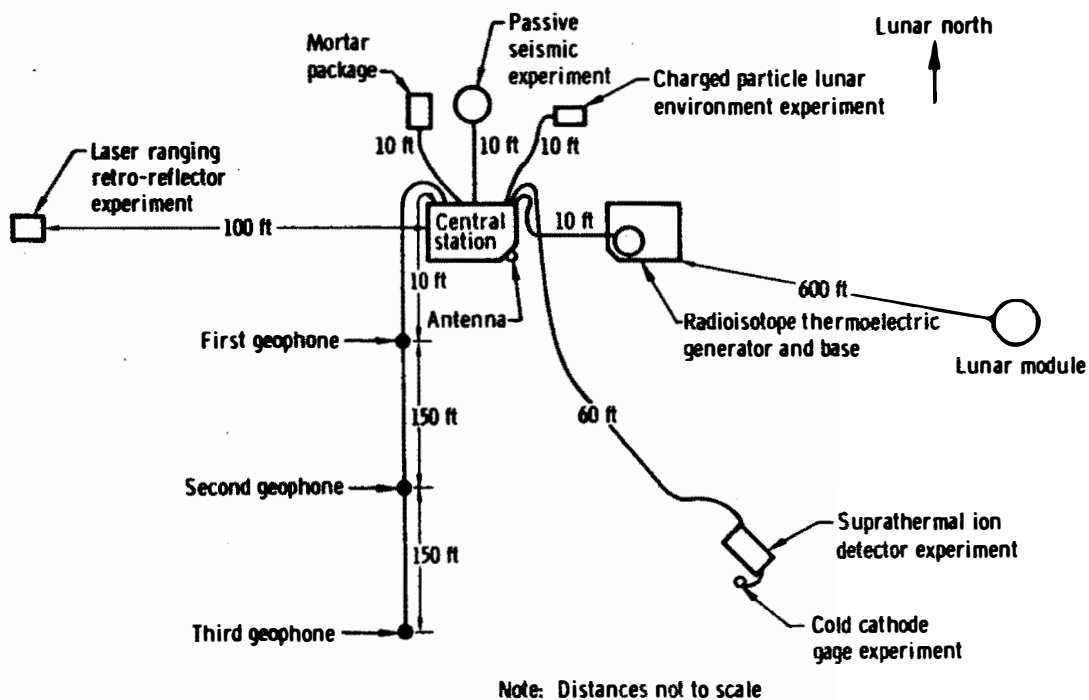
Figure 3-2.- Arrangement of the Apollo lunar surface experiments.

The Apollo lunar surface experiments package was deployed with the central station positioned 600 feet west-northwest of the lunar module (fig. 3-2). No difficulties were experienced in off-loading the pallets or setting them up for the traverse other than an initial difficulty in latching the dome removal tool in the fuel cask dome. The crew installed the fuel capsule in the radioisotope thermoelectric generator and lock-on data were obtained with initial antenna alignment at 116 hours 48 minutes.

During the deployment of the central station, the sunshield erected normally. However, the crew had to lift one side on three occasions because it was sagging. Lunar surface photography indicates that the sunshield had been bumped downward in a counterclockwise direction. However, the sagging condition has had no adverse effect on the central station thermal control system, and the central station has been operating within thermal limits.

The passive seismic experiment (ref. 2) was deployed 10 feet north of the central station (fig. 3-2). No difficulty was experienced in deploying the experiment other than the inability to make the ribbon cable lie flat on the surface under the thermal shroud skirt. All elements have operated as planned with the following exceptions.

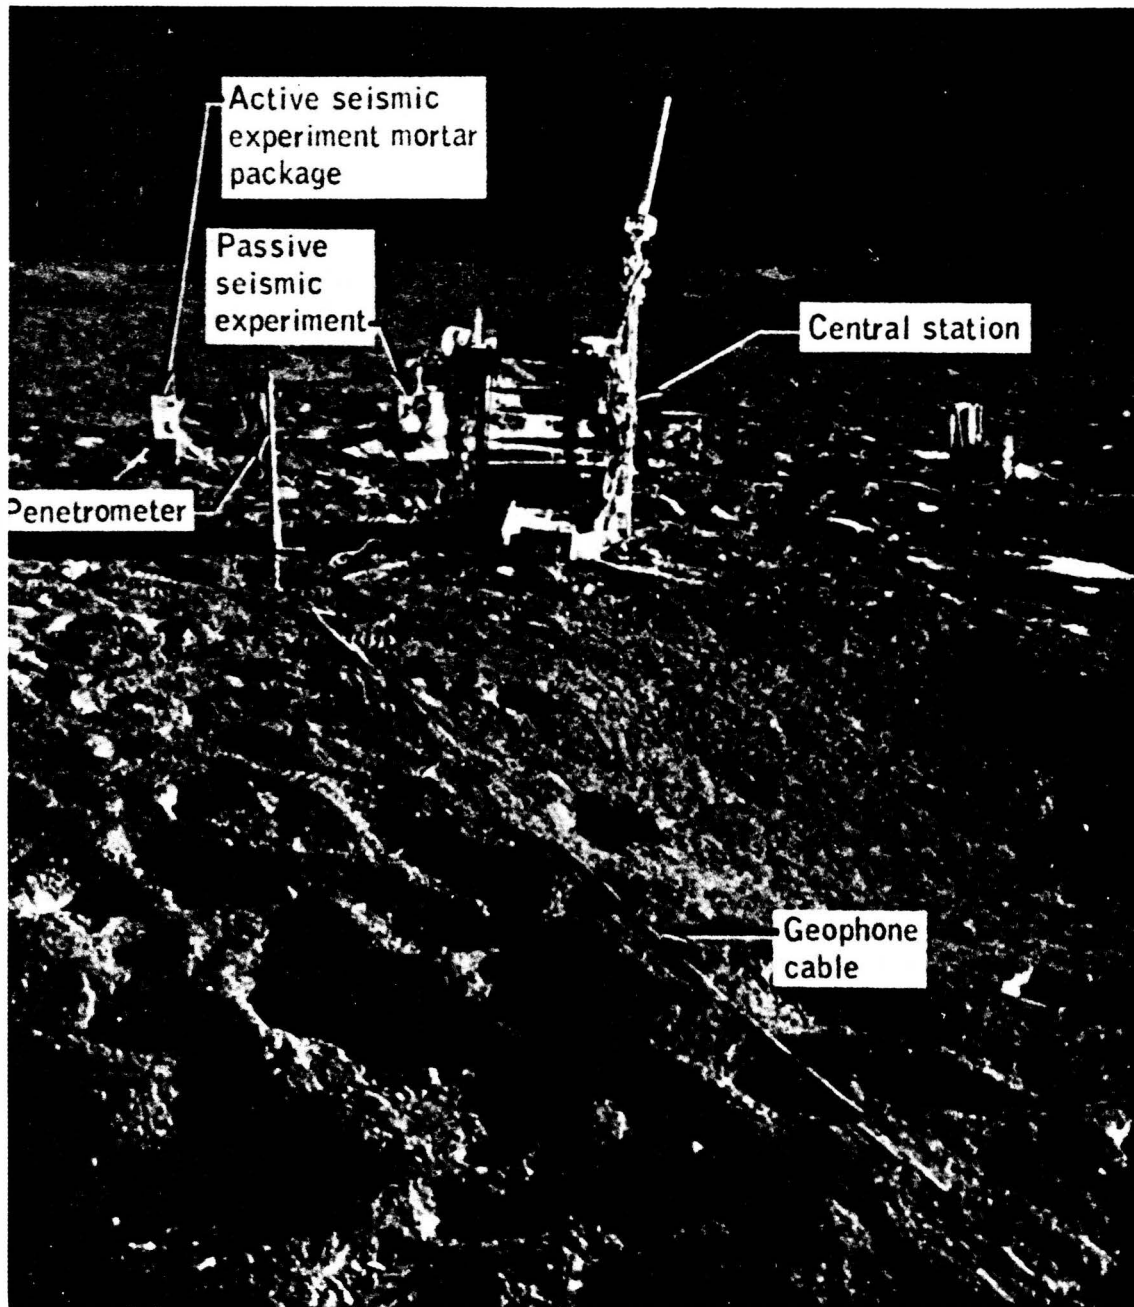
Figure 3-3.- Apollo lunar surface experiment package components deployed on the lunar surface.

The active seismic experiment (appendix A, section A.4.1) was deployed during the first extravehicular period with the first geophone approximately 10 feet southwest of the central station and the geophone array extending in a southerly direction (figs. 3-2 and 3-3). The Apollo lunar scientific experiment package was commanded to the high-bit-rate mode for 28 minutes during the active seismic experiment/thumper mode of operation. Thumping operations began at geophone 3 (the furthest from the central station) and proceeded for 300 feet at 15-foot intervals toward geophone 1.

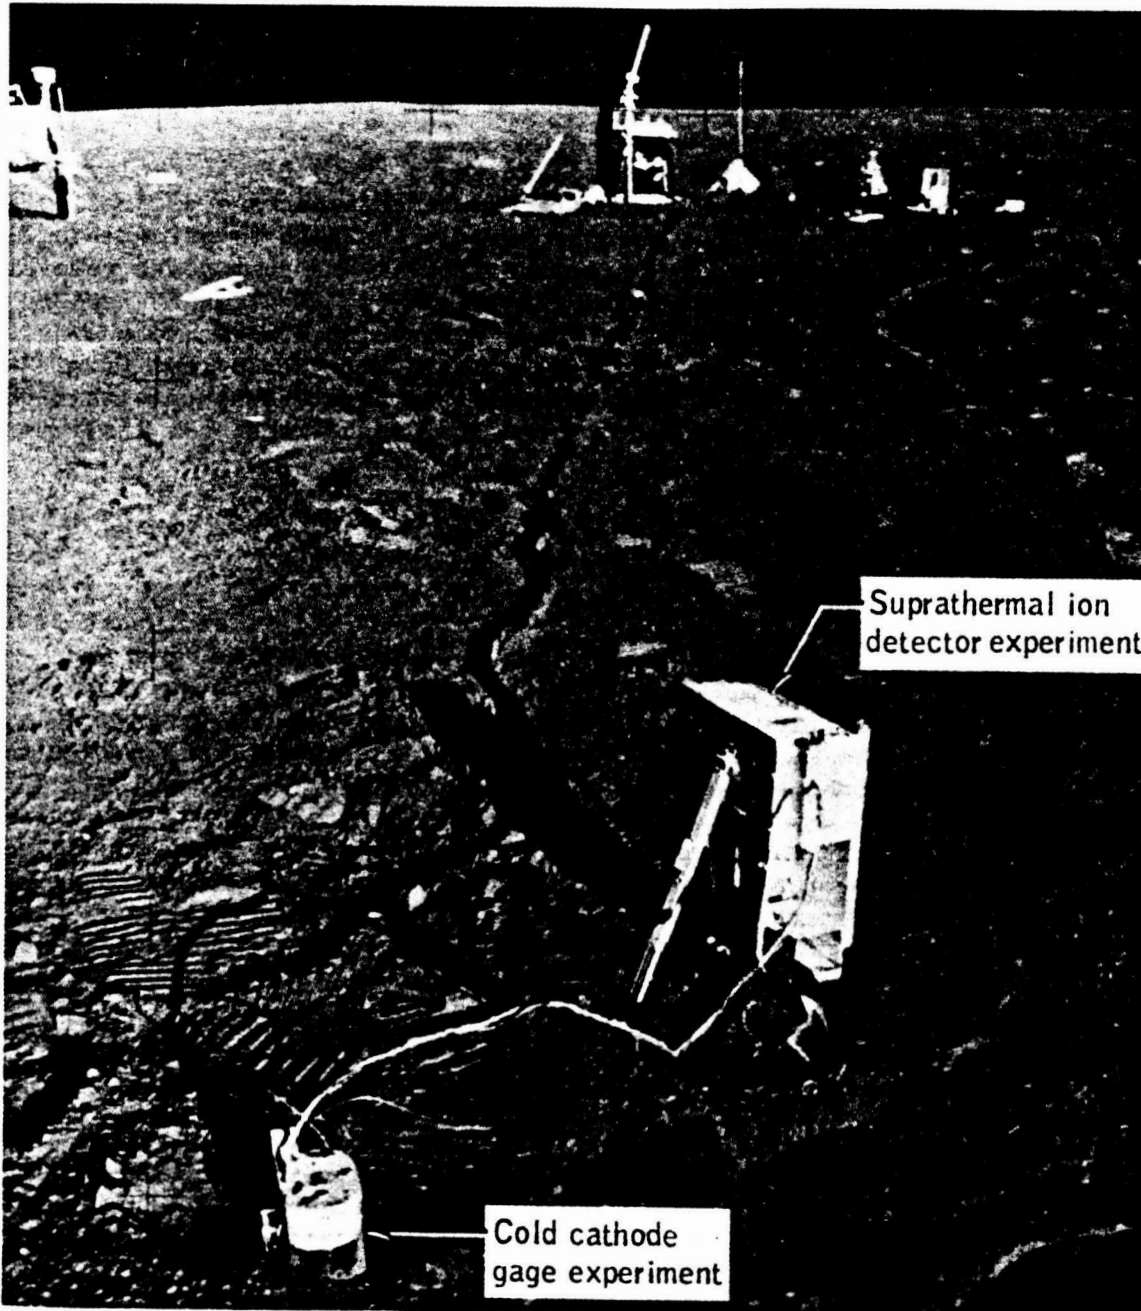
Figure 3-4.- Suprathermal ion detector experiment and cold cathode gage experiment deployed on the lunar surface.

The cold cathode gage (ref. 2) was deployed 4 feet southeast of the suprathermal ion detector, aimed slightly southwest (figs. 3-2 and 3-4). The deployment was accomplished after several attempts in which the crewman experienced difficulty with the stiffness of the connecting cables while handling the suprathermal ion detector experiment, the cold cathode gage, and the ground screen at the same time.

Because a spontaneous change in the operational mode of the cold cathode gage and the suprathermal ion detector experiment occurred after about 1/2 hour of operation, the high voltages were switched off until after lunar sunset. When the high voltages were switched back on after lunar sunset, the response of the cold cathode gage went to the most sensitive range, indicative of the low ambient pressure. When the pressure rose at lunar sunrise as expected, the mode of operation was changed by a ground command to a less sensitive range, and the calibrate pulses appeared normal. The experiment is operating normally.

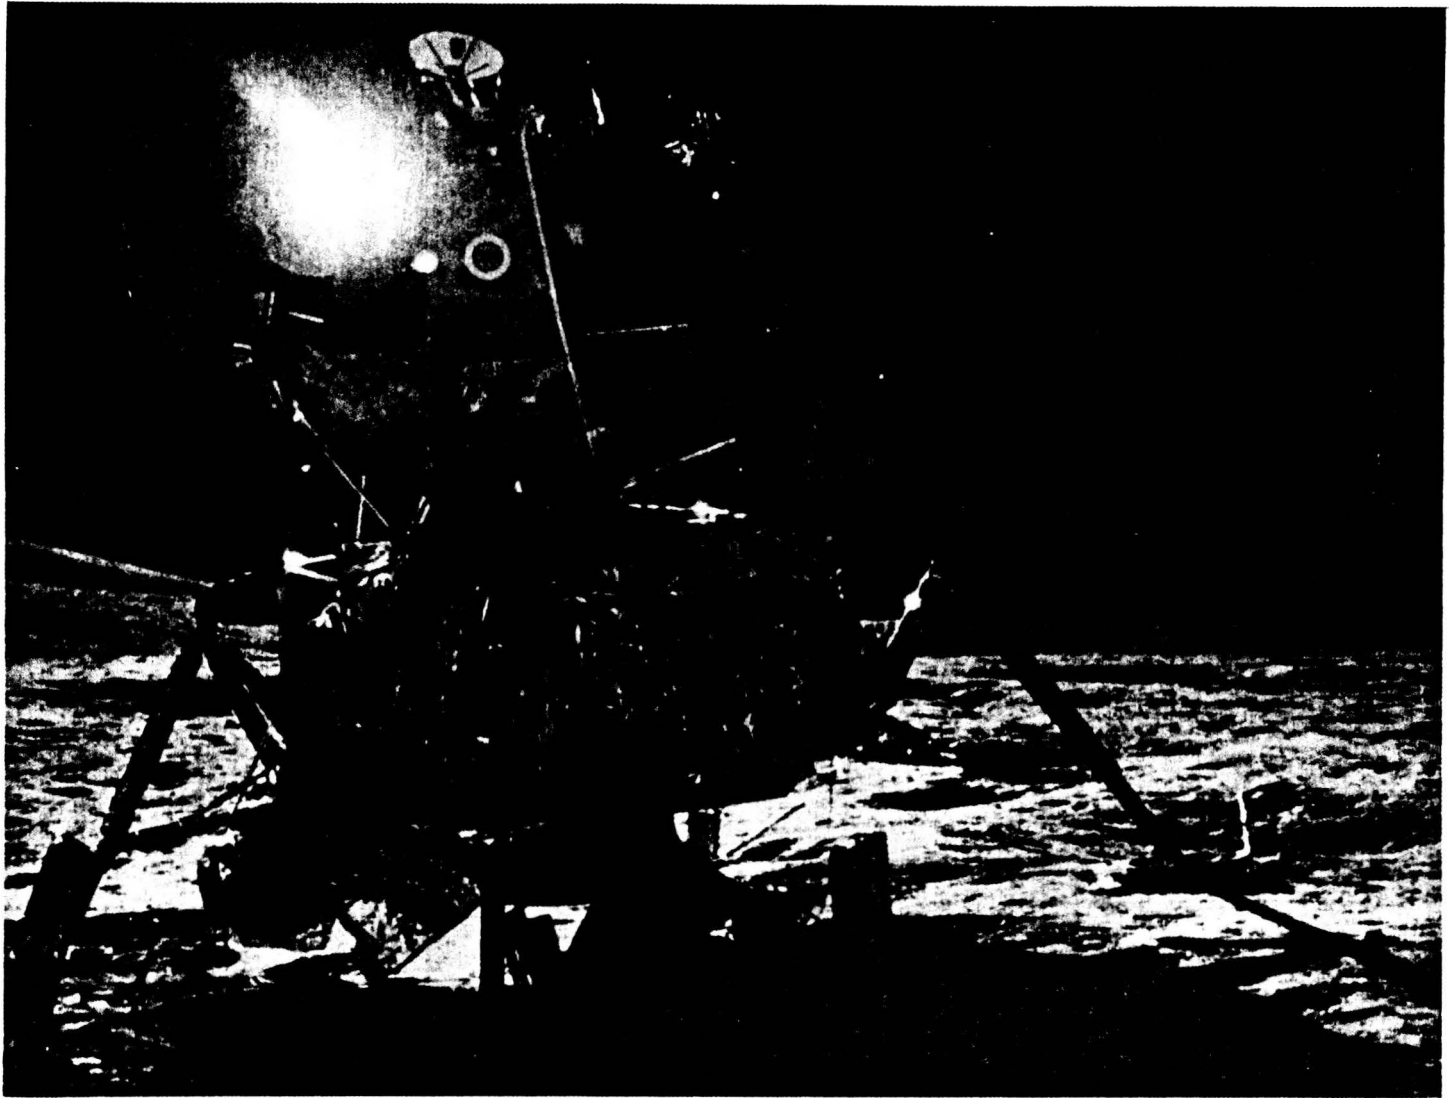
Figure 8-2.- Lunar module landing site.

6 inches in depth and rocks were readily visible through it. A final descent from 100 feet was made at a descent rate of 3 ft/sec, with a deliberate forward velocity of about 1 ft/sec and, essentially, zero cross range velocity. The forward velocity was maintained until touchdown to preclude backing into any small craters. To provide a soft landing, a delay of about 2 seconds was allowed between acquisition of the contact lights and activation of the engine stop button. Touchdown occurred at shutdown with some small dust-blowing action continuing during engine thrust tailoff or decay. The landing forces were extremely light and the vehicle came to rest within 1 degree of zero in pitch and yaw attitudes, and with a 7-degree right roll attitude (northeast tilt). (Refer to figure 8-2.)

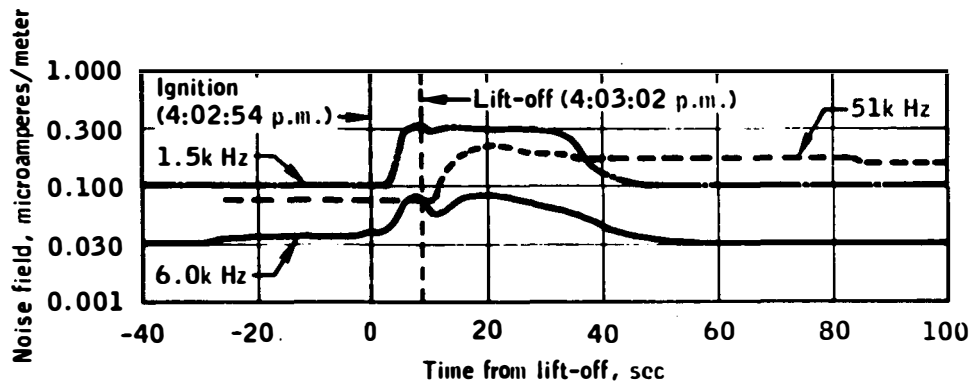
The loop-antenna data (fig. 13-3) indicate a large increase in noise on the 1.5-kHz and 6-kHz channels 3 seconds after engine ignition, while the noise on the 51-kHz channel did not begin until 2 seconds after lift-off (about 11 seconds after ignition). Initially, it appeared that the 1.5- and 6-kHz data might not represent radiated electromagnetic noise, rather, microphonic noise generated by some component of the system such as the loop antenna preamplifier. Preliminary data from the electric

Figure 13-3.- Noise recorded by loop antenna system.

dipole antenna at camera pad 5, however, indicate the same general behavior, and as the two antenna systems use separate amplifiers, it appears that the data are valid. An abrupt cessation of the 1.5- and 6-kHz noise by both systems prior to the loss of the 51-kHz noise is not understood and further studies of the noise data are presently being made.

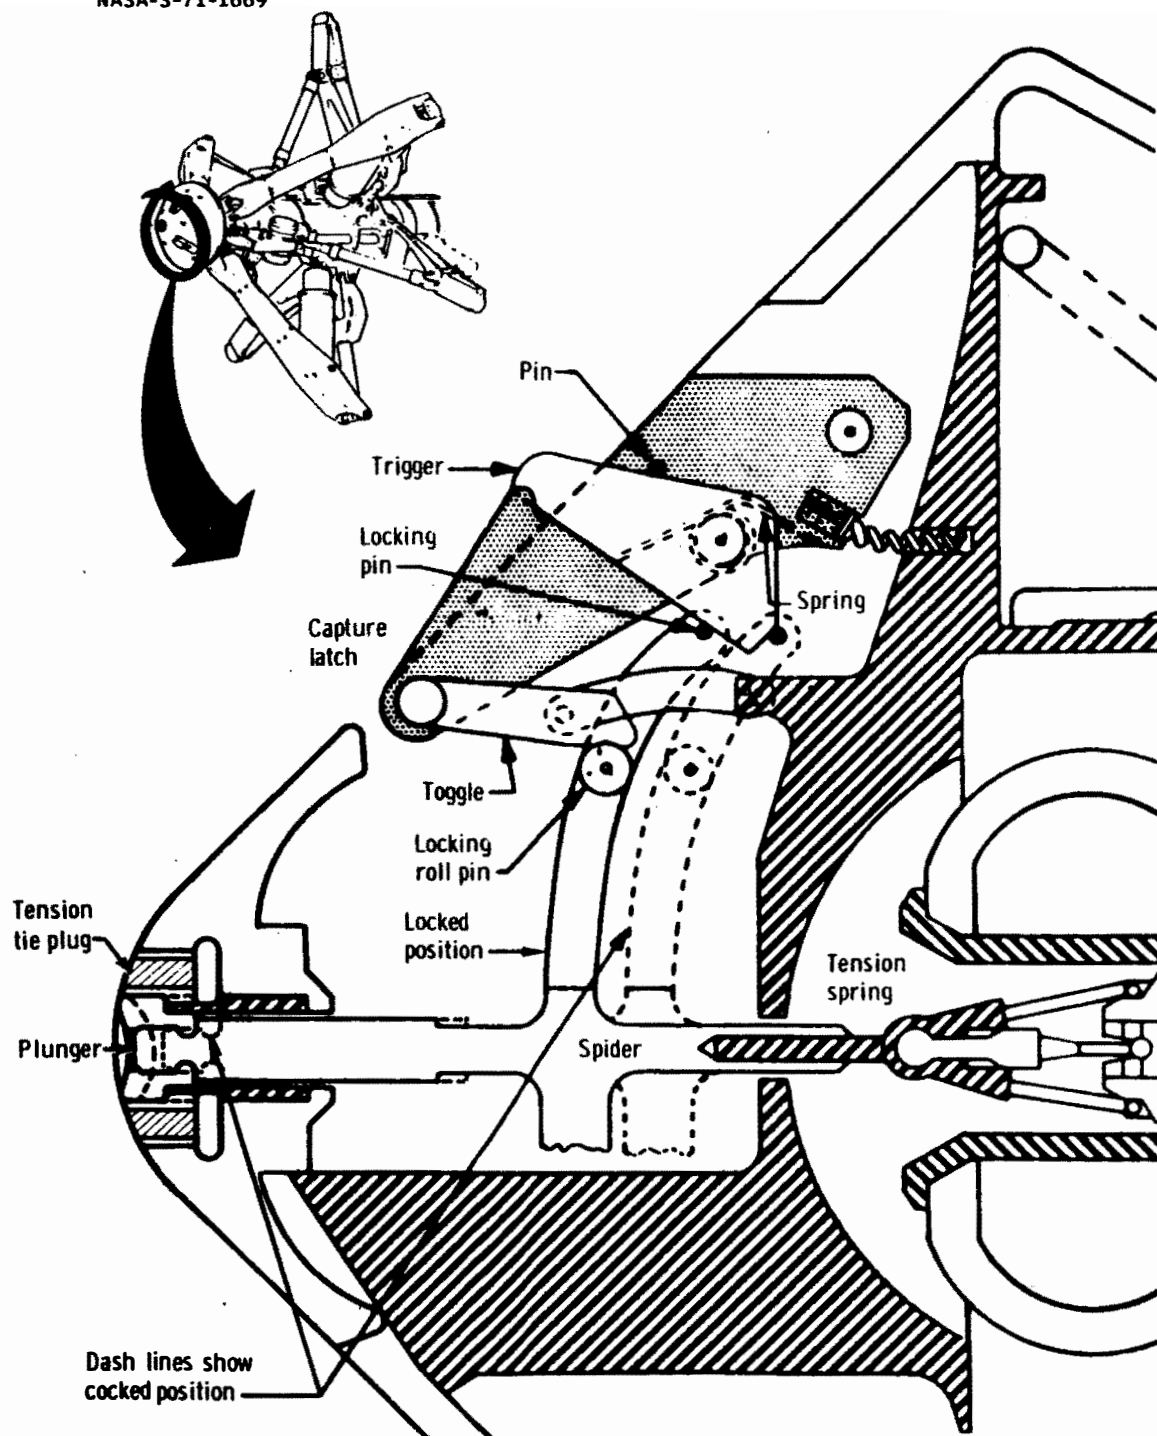
a. The probe status talkback displays functioned properly before and after the unsuccessful attempts, thus indicating proper switch operation and power to the talkback circuits. The talkback displays always indicated that the capture latches were in the cocked position during the unsuccessful attempts (fig. 14-1). (Note that no electrical power is required to capture because the system is cocked prior to flight and the capture operation is strictly mechanical and triggered by the drogue.)

Since the latches were not locked, the anomaly was apparently caused by failure of the capture-latch plunger (fig. 14-1) to reach the forward or locked position. Motion of the plunger could have been restricted by

Figure 14-1.- Cross section of probe head and capture-latch assembly.

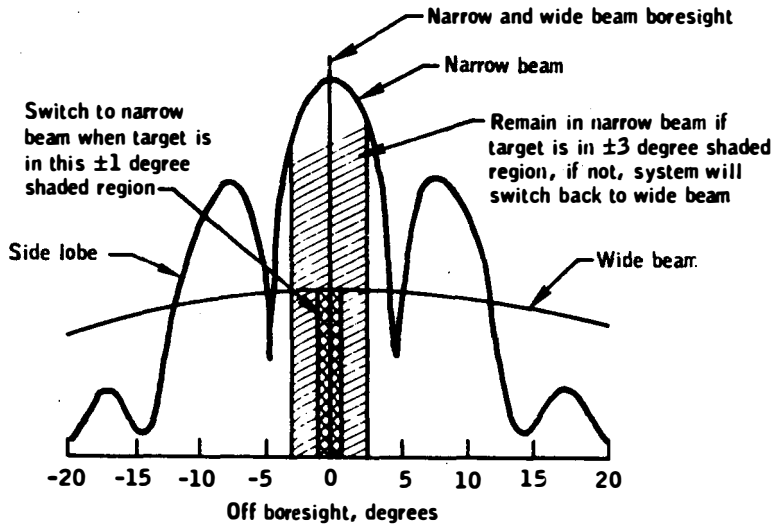
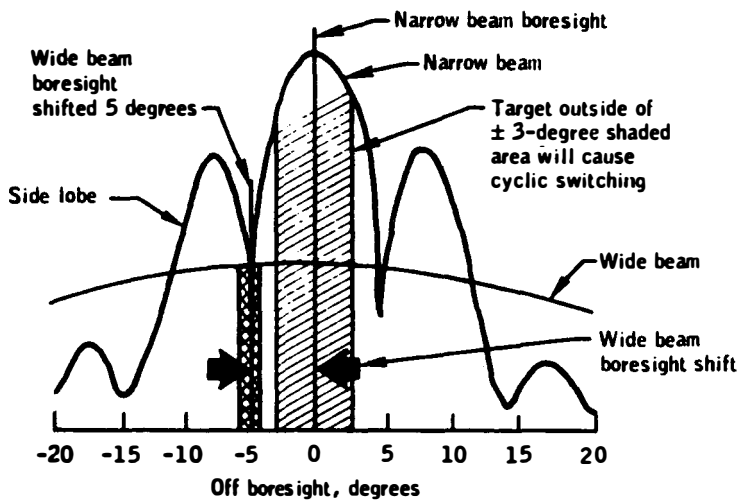
The low signals correlate with antenna pattern and gain data for a 5- to 8-degree boresight shift in the wide-beam mode. The direction of the spikes observed on the downlink data in figure 14-3 are consistent with switching between the wide and narrow beams. Conditions for a normal alignment and a misalignment of the wide and narrow beams are shown in figure 14-4. A 5- to 8-degree shift in the wide-beam mode boresight  
 NASA-S-71-1672

Figure 14-4.- Antenna narrow and wide beam boresight relationship.  
 Figure 14-4.- Antenna narrow- and wide-beam boresight relationship.

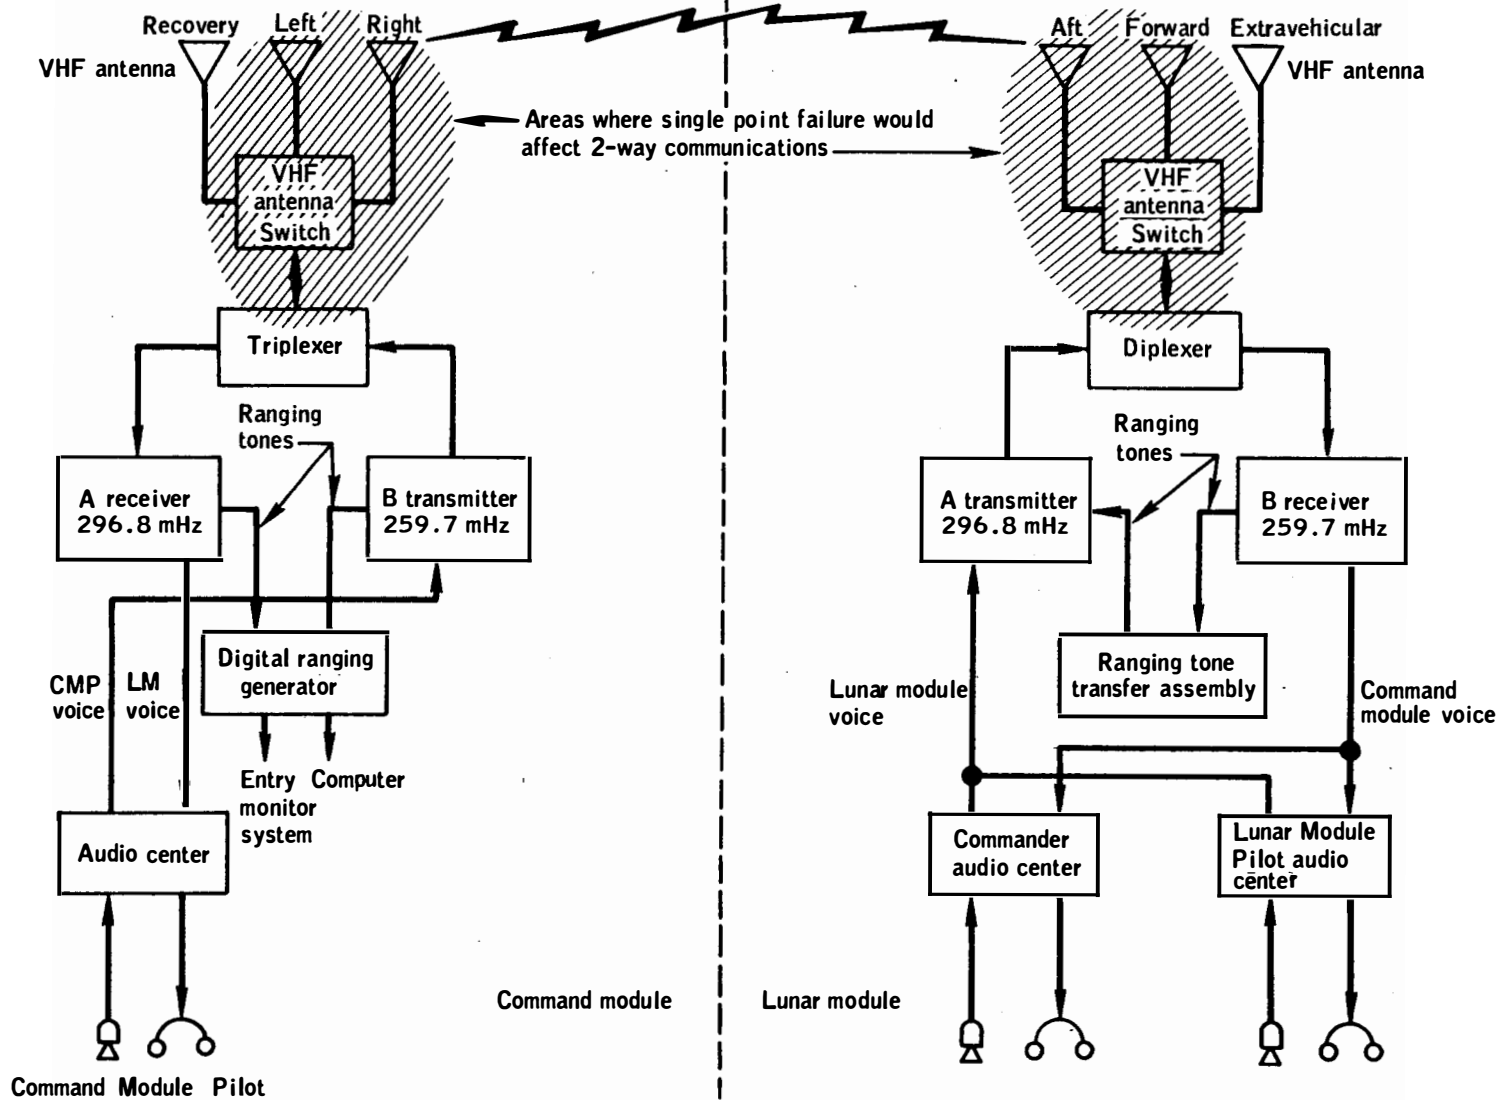
The lower-than-normal RF link performance was a two-way problem (voice was poor in both directions); therefore, certain parts of the VHF system are prime candidates for the cause of the problem. Figure 14-9 is a block diagram of the VHF communications system as configured during the rendezvous phase of the mission. Also shown are those areas in which a malfunction could have affected the two-way RF link performance. A single malfunction in any other area would have affected one-way performance only.

Figure 14-9.- Block diagram of VHF communications systems.

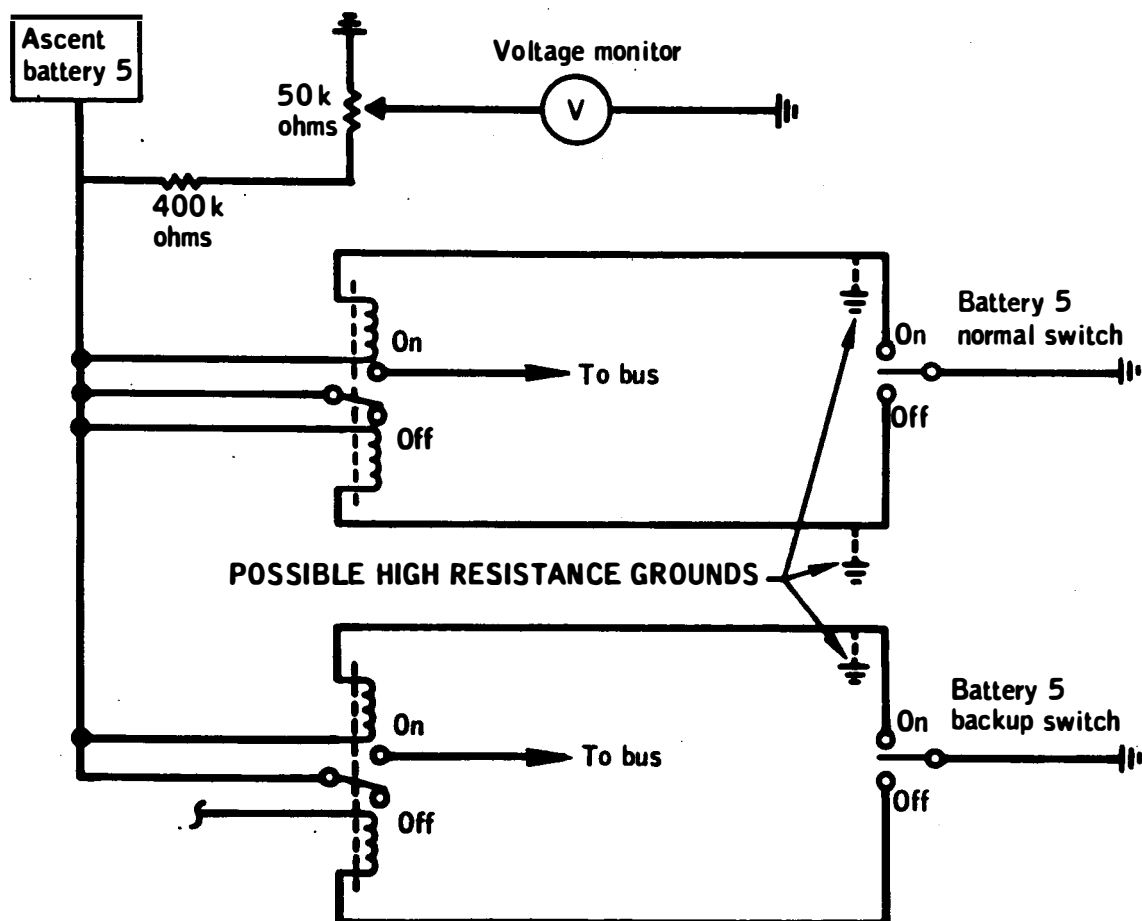
An external battery load could have existed from lift-off to 62 hours on the circuit shown in figure 14-16 in which typical types of high resistance shorts are also shown. For this condition, the current drain would have occurred on all cells. Figure 14-14 shows the time history of the

Figure 14-16.- Ascent battery 5 configured for open-circuit loads.

open-circuit bus voltage for battery 5. For a constant external load, the battery 5 open-circuit bus voltage would have been lower than the flight data at 141 hours. Therefore, the external load would have had to change with time.

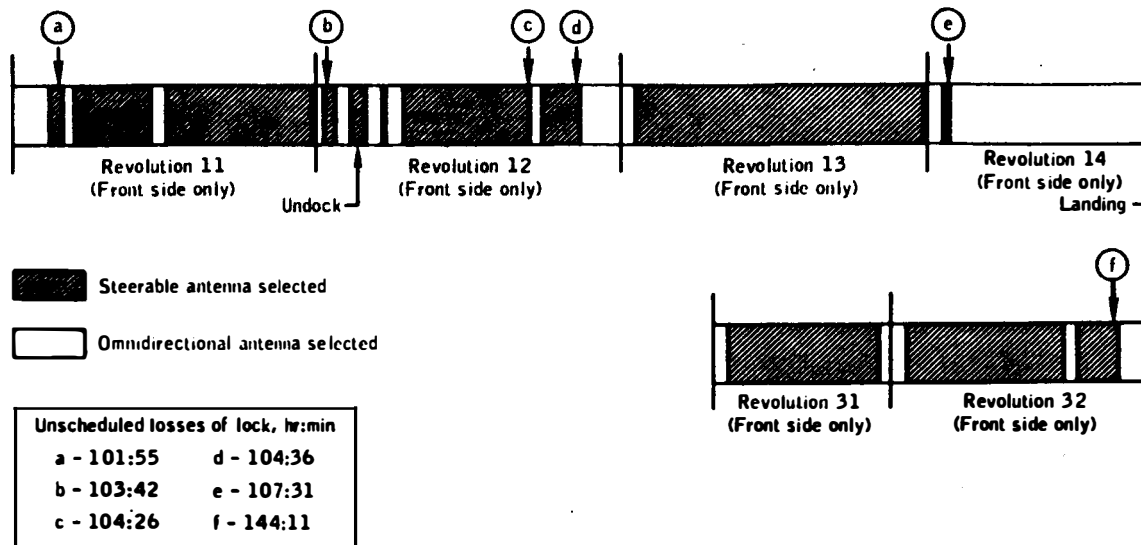
Figure 14-19.- S-band steerable antenna operation.

antenna response. It indicates that the antenna began to experience a mechanical oscillation of approximately 2 to 3 hertz, which became increasingly larger in amplitude until the antenna lost lock. When antenna oscillations exceed plus or minus 5 degrees, excessive motor drive current causes the 28-volt dc circuit breaker to open and the antenna ceases to track. The crew reset this circuit breaker several times. The antenna was also reported to be noisy, indicating the continual driving that would have occurred during the oscillations. The oscillations occurred randomly at other times during the problem period, but damped out and did not cause tracking interruptions.

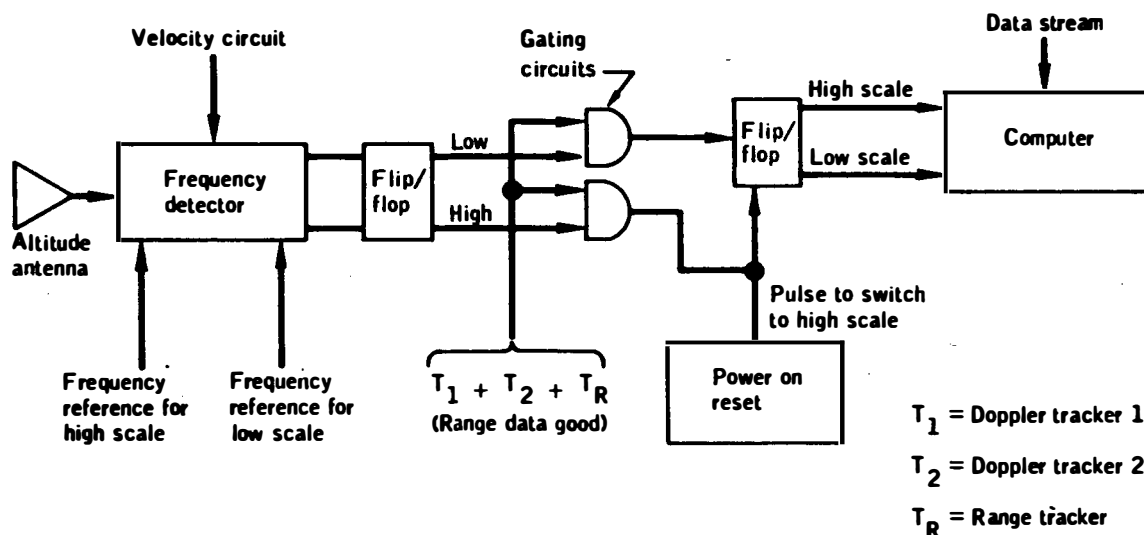
Two conditions occurred during the landing radar operation which were not expected; however, they were not abnormal. The first condition occurred approximately 6 minutes after initial actuation of the landing radar. The system switched to the low-range scale, forcing the trackers into the narrow-band mode of operation. This was corrected by recycling the main power circuit breaker which switched the radar to high scale. Figure 14-21 shows the radar scale switching logic. The radar then locked on and "velocity-data-good" and "range-data-good" indications were transferred to the computer. The "velocity-data-good" signal is generated when the Doppler trackers lock on and the "range-data-good" signal is generated when the range tracker also locks on.

Figure 14-21.- Landing radar scale switching logic.

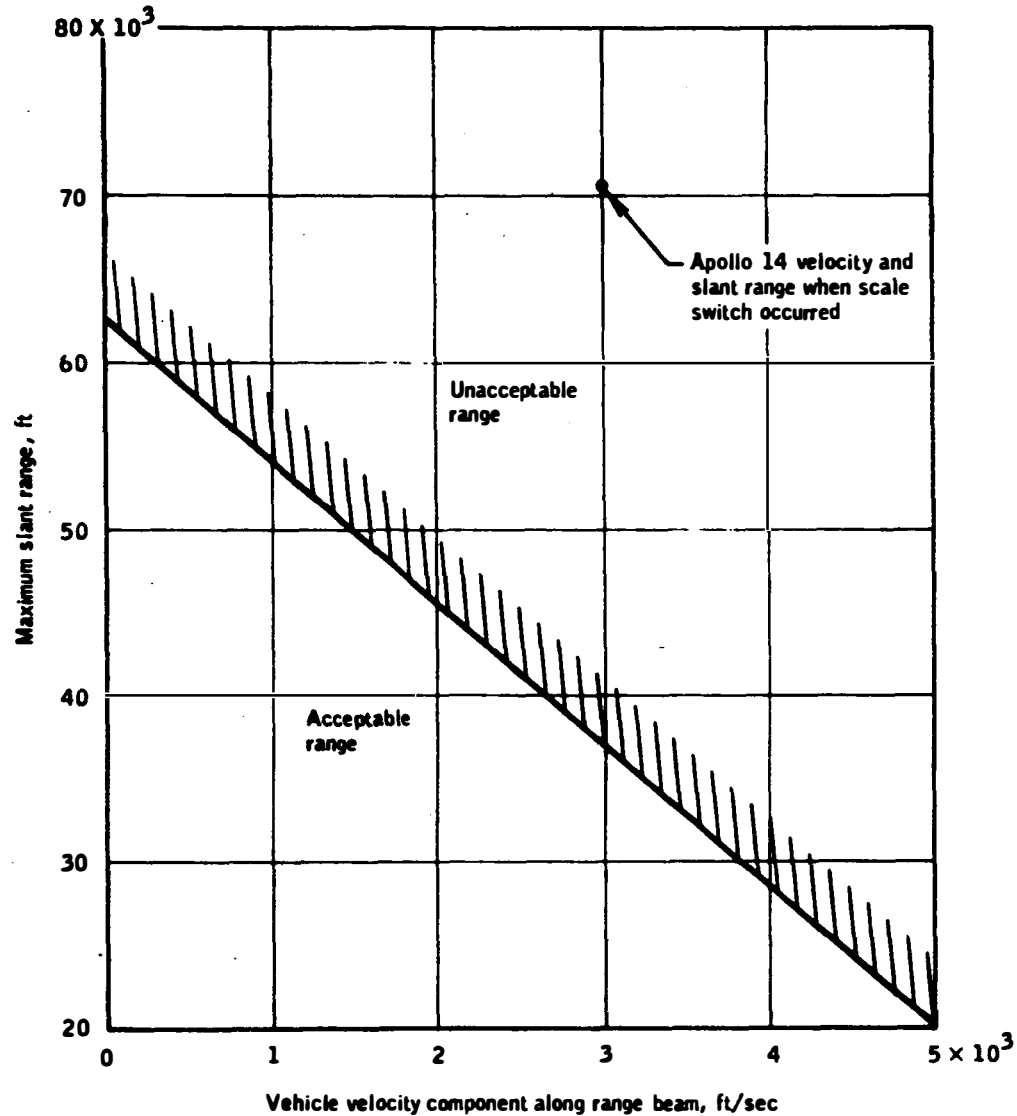
The scale switching occurred at a slant range of 63 000 feet with a beam velocity of 3000 ft/sec at an incidence angle of 35.4 degrees. Operating the landing radar under these conditions exceeds the maximum range measurement design limit (fig. 14-23). Under these conditions, the receiver is sweeping with maximum gain and the system will be sensitive to any received noise. A test was performed with a radar operating under the Apollo 14 conditions (two range-rate beams locked up and the range beam unlocked). By inserting low-level noise for a fraction of a second into the receiver, range scale switching occurred.

Figure 14-23.- Landing radar range measurement design limitation as a function of vehicle velocity component along range beam.

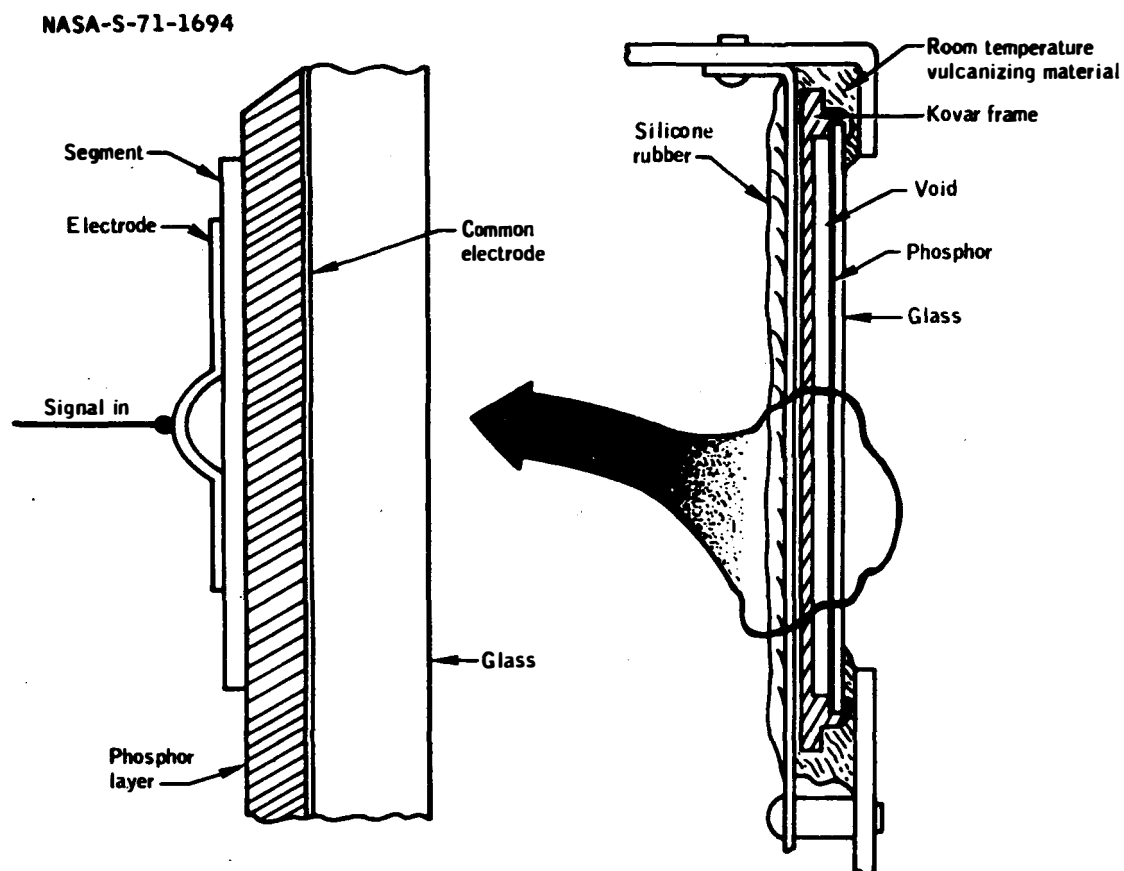
The crew reported a crack in the glass across the address register of the data entry and display assembly. Figure 14-25 shows the assembly and the location of the crack. Figure 14-26 is an enlarged drawing of the glass and associated electroluminescent segments.

Figure 14-26.- Cross section of data entry and display assembly glass.

The cause of the crack is unknown. Glass cracks have not occurred since a revision was made to the procedure used to mount the glass to the faceplate of the data entry and display assembly. The assembly is qualified for an environment in excess of the flight conditions. Therefore, either excessive internal stresses (under normal conditions) were built into the glass, or the mounting was improper (not as designed), or the glass was inadvertently hit.

Corrective action consists of applying a clear plastic tape prior to flight on the glass of the electroluminescent windows above the keyboard (fig. 14-25), like that previously used on the mission timer windows. The tape is to prevent dislodging of any glass particles if cracks occur in the future, as well as help prevent moisture from penetrating

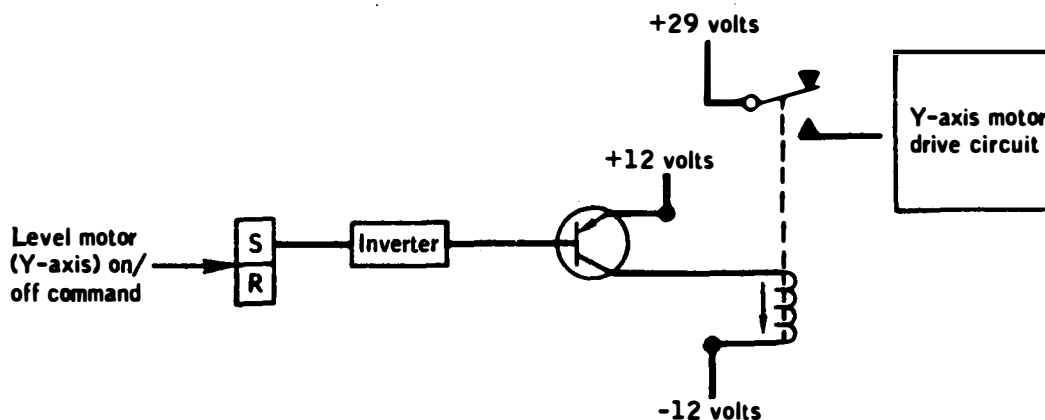
Figure 14-33.- Y-axis leveling motor circuitry.

Although no scientific data have been lost to date, intermittent problems have been encountered when leveling the Y-axis of the gimbal platform upon which are mounted the three orthogonal long-period seismometers. Occasionally, either there is no electro-mechanical response, or the response is delayed when the Y-axis motor is commanded on. Delay times vary. Thus far, leveling has been achieved by cycling on/off commands at varying time intervals.

The problem is caused by an intermittent component in the motor control circuit (fig. 14-33). There is no correlation between the occurrence of the problem and the temperature of the lunar surface, the central station electronics, or the experiment. Whenever there is an indication of power to the motor, the motor operates. When the motor operates, it operates properly and pulls the normal current.

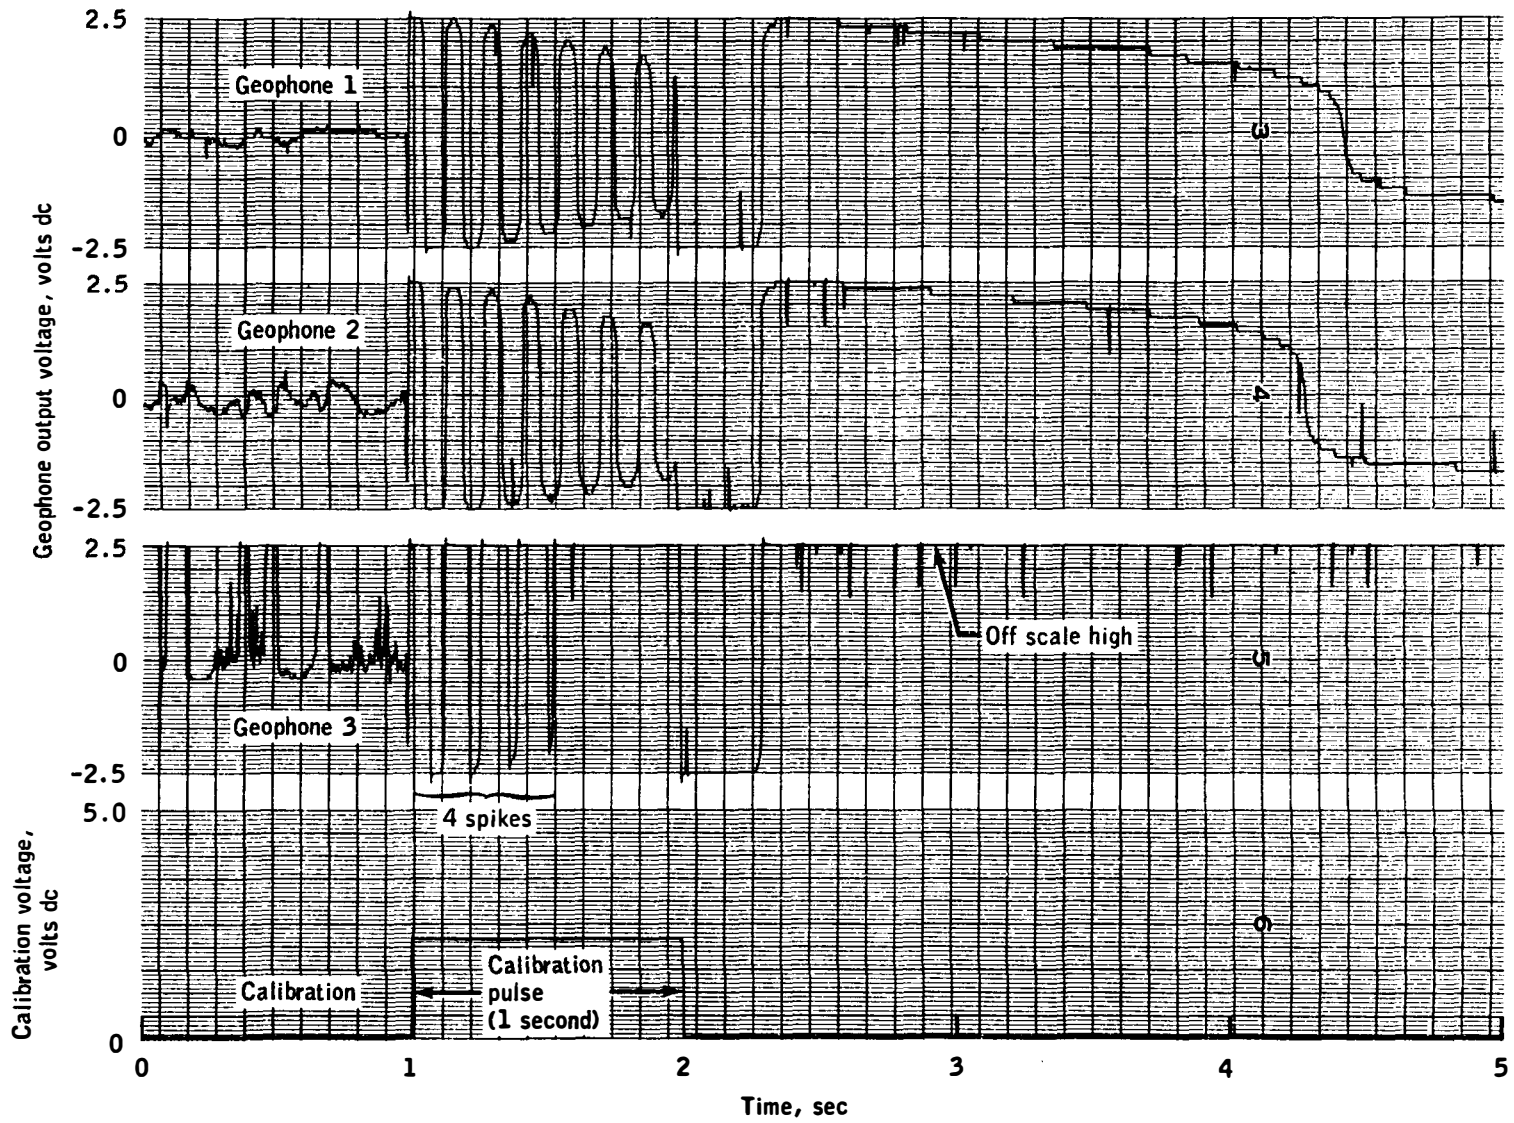
The experiment was turned on in the listening mode on March 26, 1971, and geophone 3 data were spiking off-scale high (fig. 14-34). When the geophone channels were calibrated, the geophone 3 channel went off-scale high simultaneously with the start of the calibration pulse and stayed off-scale high for the remainder of the listening period. During the 1-second period when the calibration pulse was present, data from geophones 1 and 2 showed the normal 7-hertz ringing caused by the calibration pulse. However, geophone 3 data showed four negative-going spikes coincident with the first four negative half cycles of the ringing on the other two channels. The spikes decreased in duration from the first to the last, the last having an amplitude of 90 percent of

Figure 14-34.- Geophone calibration data.

full scale (plus 2.5 volts to minus 2.0 volts). During the time that this pulse was present, the signal on channel 2 changed from minus 2.2 volts to minus 2.35 volts, indicating that channel 3 was operating at an apparent gain of 30 times the channel 2 gain.

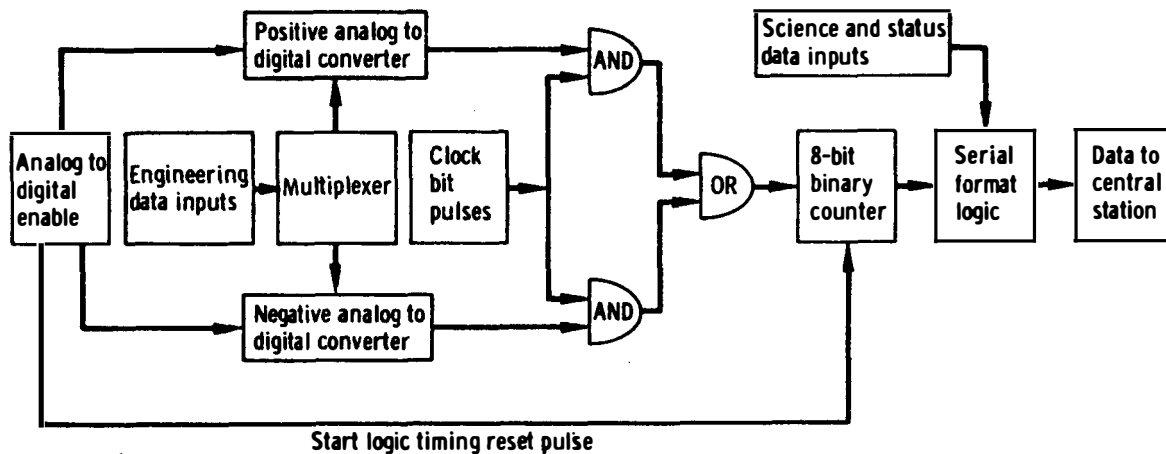
An intermittent failure of the start reset pulse for the positive log analog-to-digital converter control logic (fig. 14-37) could cause the problem. Although the failure permits the positive converter initial output to fill the eight-bit binary counter and produce a full-scale reading; thereafter, when a start pulse for the positive converter should reset the eight-bit counter, it fails to do so, and the negative word which is still in the counter is read out as a positive word. The cause appears to be an intermittent component or wire connection in one of the associated modules. However, it does not appear to be a function of the temperature. The components have been passed by normal high reliability screening, and systems tests have included operational pressure, temperature, vibration, humidity, and accelerated lunar environment cycles. No failure of this

Figure 14-37.- Simplified data logic control.

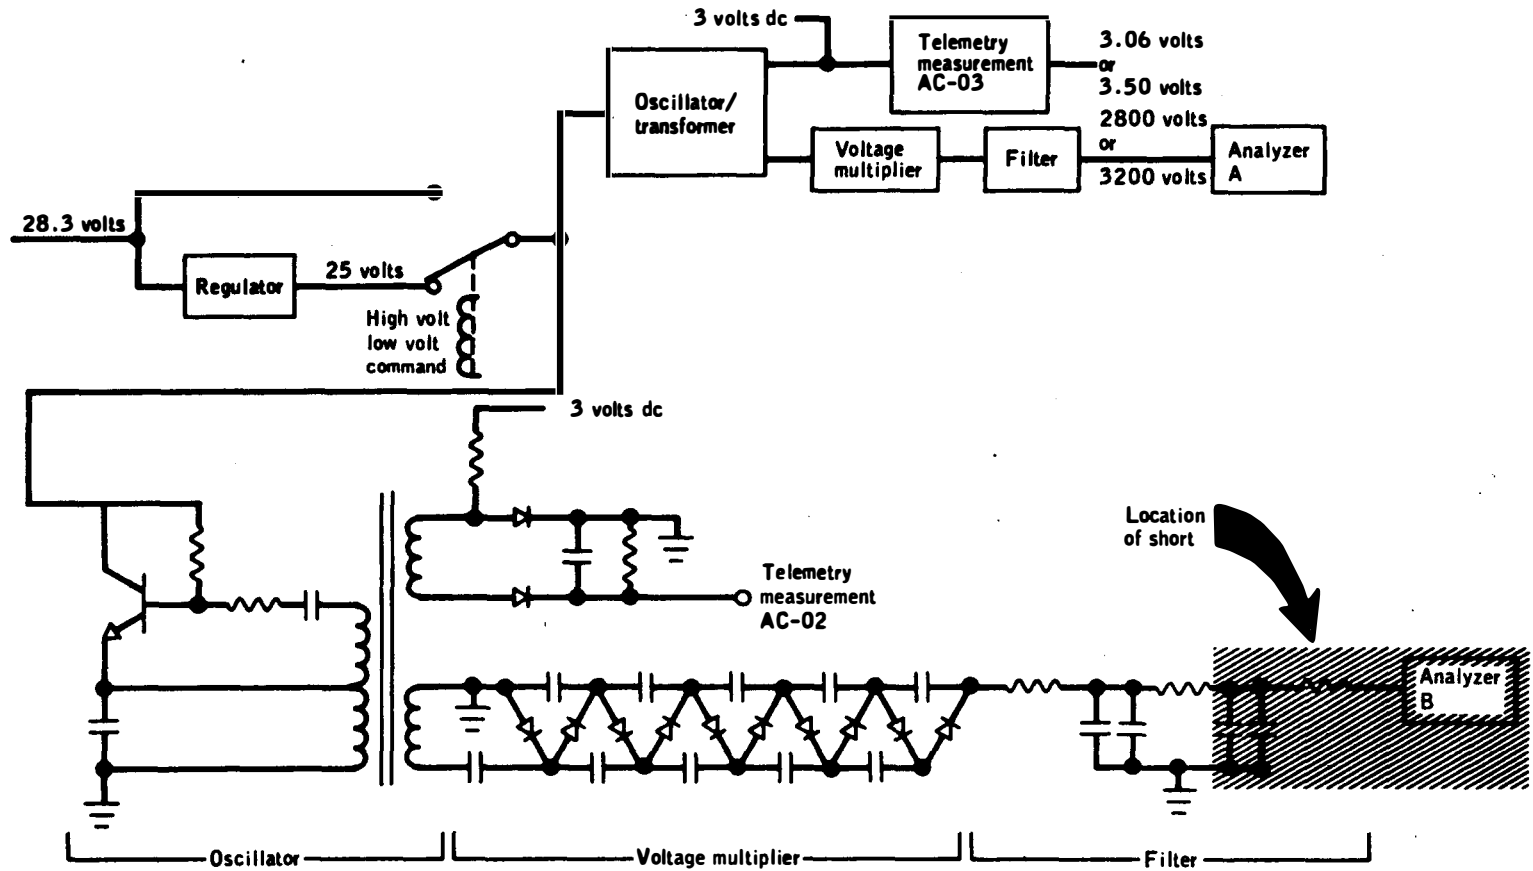
The voltage measurement reading on the analyzer B power supply (fig. 14-38) became erratic on April 8, 1971, and the analyzer B science data were lost.

Figure 14-38.- Analyzer power supplies.
